# Barbados Screwdock – oldest surviving shiplift in the world

In December 2009 Keith Mackie was in engineers' heaven – sitting by the sea in Barbados on a pile of rusty iron, measuring it up as part of his involvement in the possible restoration of the Barbados Screwdock. Here he shares some fascinating facts with us

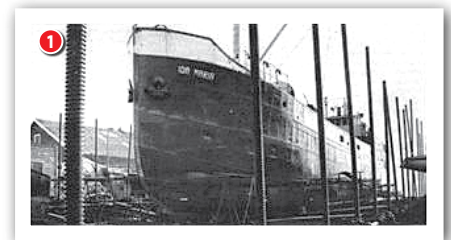
1 The Barbados Screwdock with maximum vessel in the early 20th century

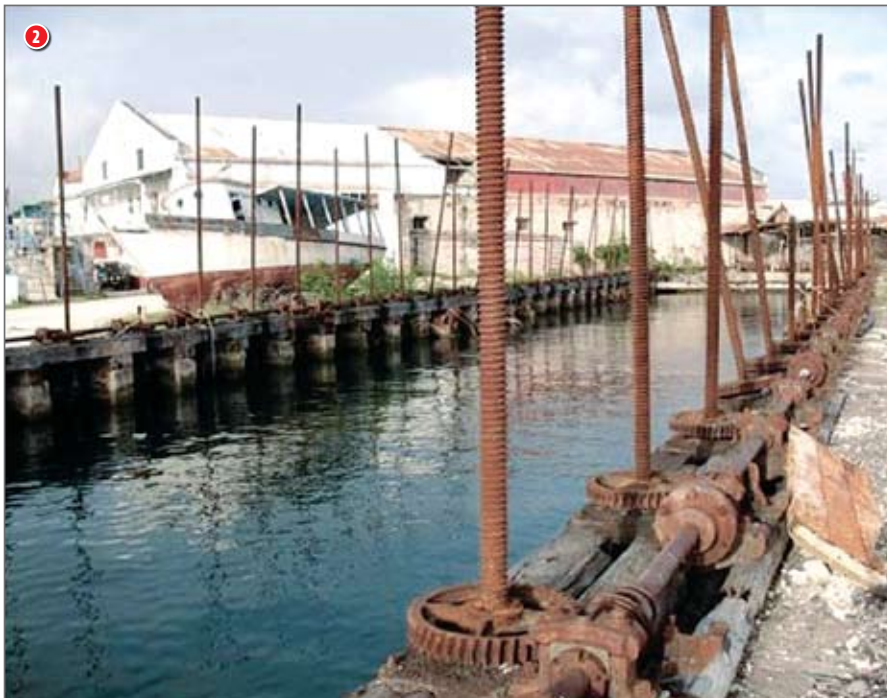
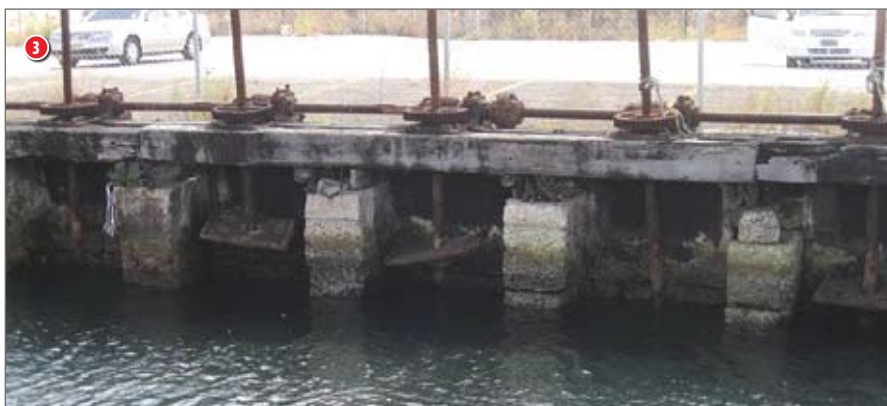
- 2 The screwdock as it is today
- 3 Piers, copes and screws

The design of the screwdock is a superb example of Victorian engineering, representing dry dock design at its best – good even by modern standards (Figures 2 & 3). The two primary elements that formed the basis of the design are unique: the use of power screws for lifting and trussed timber beams for the transverse girders.

The retaining walls to the docking pit were built of hard coral blocks – the only stone available on the island – with piers at the same 7’0” centres. The copes to the docking pit are formed of a pair of 12” (365 cm) square greenheart timber baulks laid side by side spanning across the piers. The screwjacks are supported by these cope baulks at mid-span between the piers.

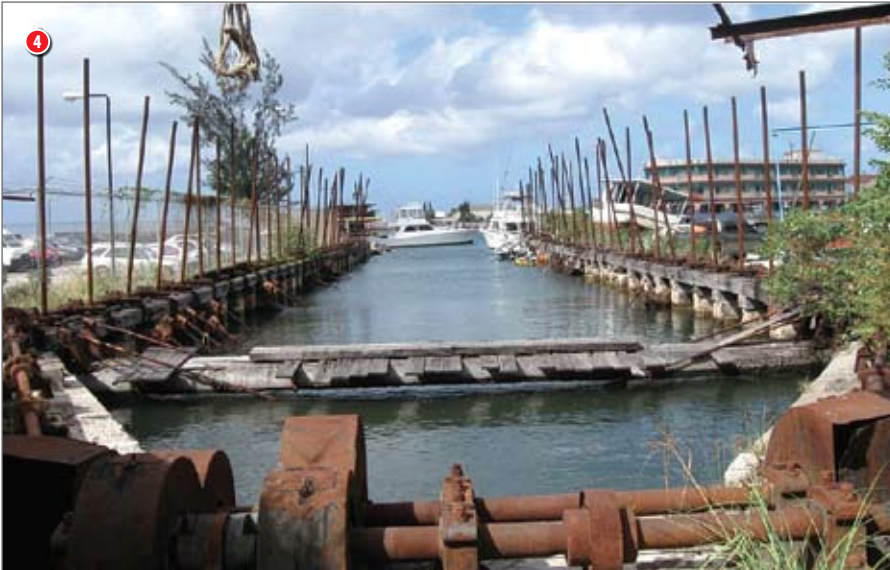
- 4 The last cross-beam
- 5 Truss tie rods and brackets
- 6 Beam support plate at end of screw rod
- 7 Main drive
- 8 Gear change (note the two-way bronze dog clutch and handle)

Each transverse girder is formed from a pair of 20” by 20” (50,8 by 50,8 cm) baulks of greenheart timber (given, in some references as “whalebone” greenheart) laid side by side. Each end of each baulk rests on one side of a cast iron plate at each end hanging off the screw rods.

A cotter and washer system underneath these plates transfers the load to the screw rods. A cast-iron bracket at each end of each baulk (a pair at each end of each beam) anchors the 2" (5.0 cm) steel truss rods. These pass each side of the baulks and under cross-timbers under the baulks (Figures 4, 5 & 6).

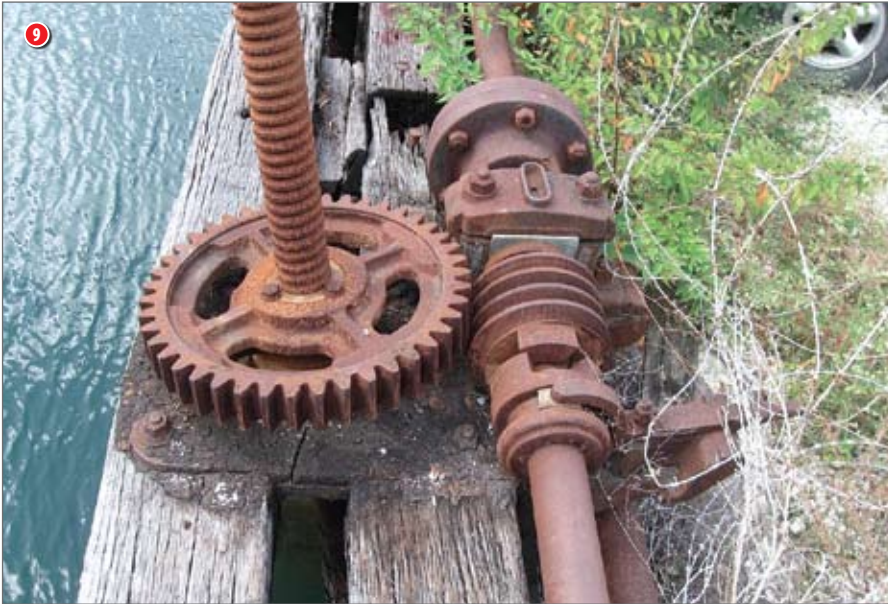
9 Worm, wheel, screw and dog clutch set (note crack in base plate)

At each screw a sliding dog clutch keyed to the drive shaft engages a worm wheel that floats on the shaft (Figure 9). The worm in turn engages a gear wheel that has a bronze nut/thrust washer embedded in it (Figure 10). The screw rod passes through the nut and is raised or lowered depending on the direction the wheel turns.

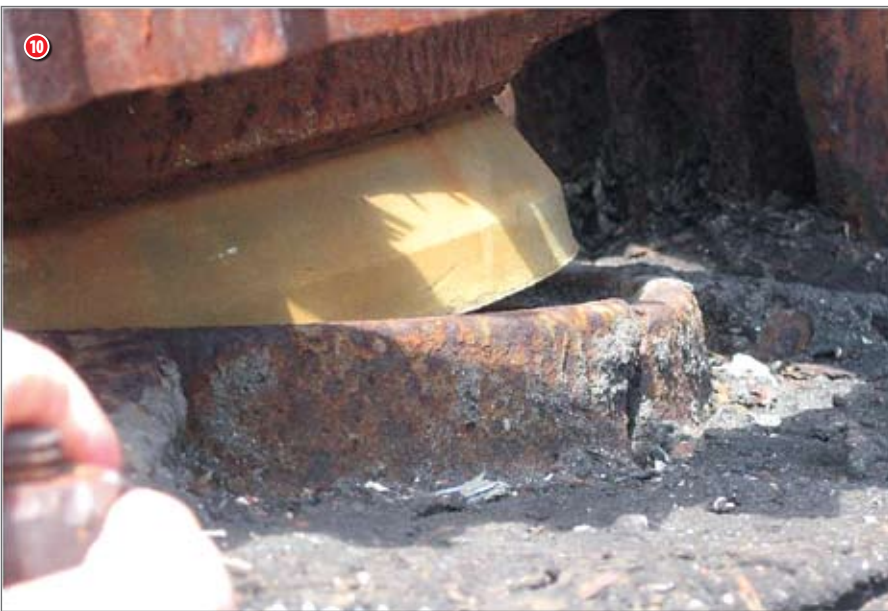
10 Bronze thrust washer (note cracked oil bath)

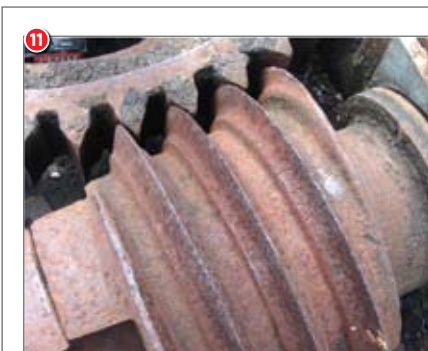
11 Various conditions of worm and wheel

▶ Worn worm and wheel

The worm and wheel sets are diagnostic of the quality of management and maintenance of the dock in its last days. Both worms and wheels come in a full spectrum of conditions from almost new to the teeth worn to sharp edges and virtually unworkable. (Figure 11).

Surprisingly, all the wheels are spur gears, which is completely inappropriate for this use and explains why both worms and wheels had to be replaced at regular intervals. In the 1890s, when the facility was built, the technology of worm and wheel gearing was well established. It seems highly unlikely that these were original equipment. However, when and why the wheels were changed to spur gears is completely unknown.

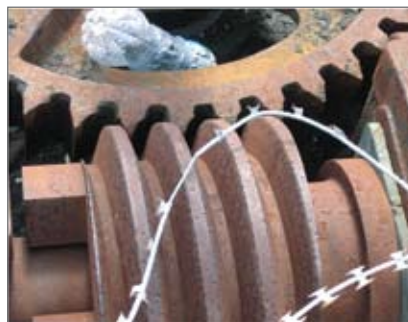
▶ New worm and worn wheel

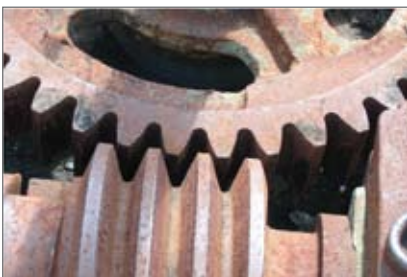
▶ Worn worm and new wheel

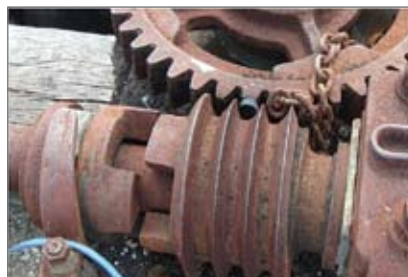
▶ New worm and wheel
